# CASE STUDY

## FLAMINGO LAND, MALTON

Client: Flamingo Land Resort  
 Main Contractor: EC Surfacing Ltd  
 Road Location: Flamingo Land, Kirby Misperton, Malton, YO17 6UX  
 Road Type: Access carriageway  
 Description of Work: Road reconstruction incorporating asphalt reinforcement system  
 Geosynthetic Installed: GLASSCOMP G 100  
 Area: 1950m<sup>2</sup>  
 Bitumen Bond Coat: Colbond 50 applied at 1.0 L/m<sup>2</sup>  
 Installation Records: As Built Manual, Quality Manual & Installation Assessment Forms  
 Crack Map Survey: N/A

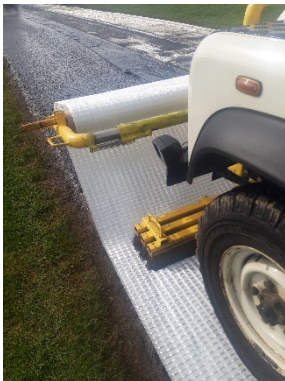
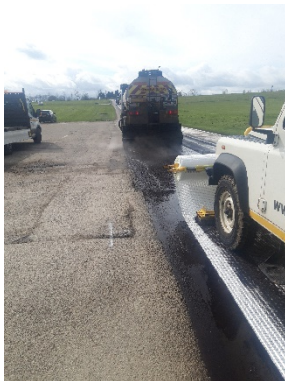
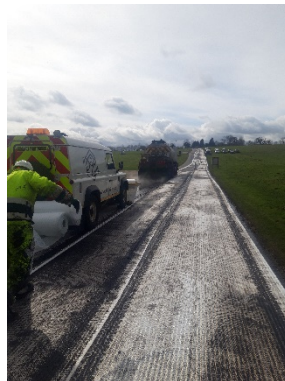
Reflective cracking, rutting and fatigue to access road.

Install GLASSCOMP G 100 onto existing asphalt surface, overlay with 50mm SMA surface course.

A design incorporating GLASSCOMP G 100 pavement reinforcement system to prevent the reoccurrence of reflective cracking, rutting and fatigue. GLASSCOMP G 100 was installed by the Road Solutions Ltd team of certified and experienced operatives, working over day shifts. Output average 1950m<sup>2</sup> per shift.
